**COMMERCIAL VEHICLE AUCTIONS LTD**  
THE UK'S MOST ESTABLISHED COMMERCIAL VEHICLE AUCTIONEERS

# VEHICLE INSPECTION REPORT

**YK71KHR**

## Mercedes-Benz Actros 2545

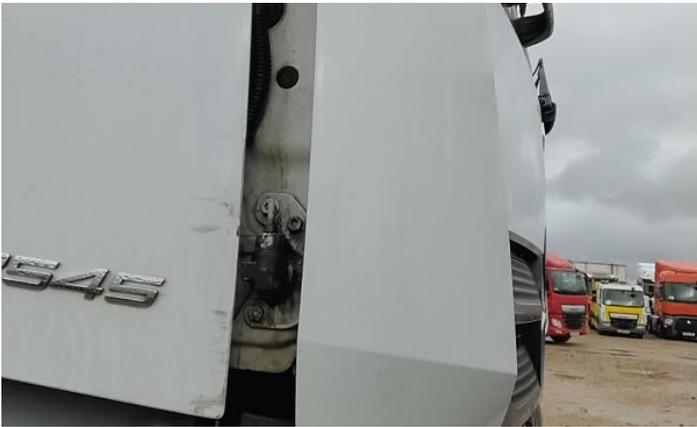
1: Wing osf  
Missing  
Replace

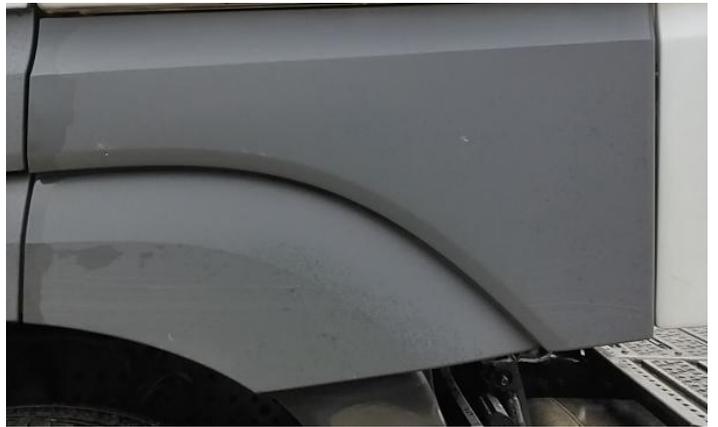
2: Wing Front Arch Extension ns  
Scuffed (Unpainted)  
Over 100mm

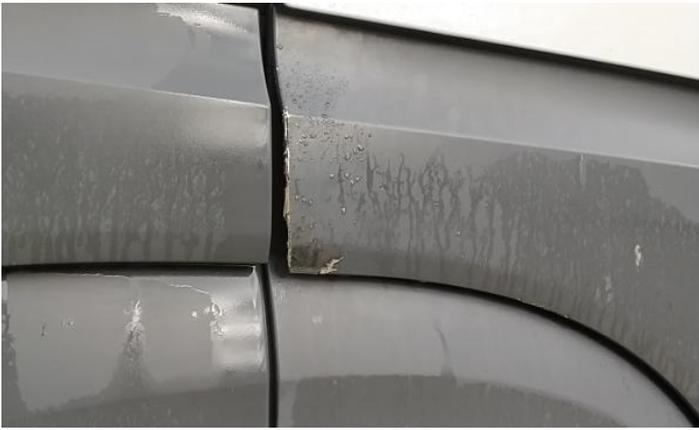
3: Wing Front Arch Extension os  
Scratched (Painted)  
Over 25mm Thru Paint

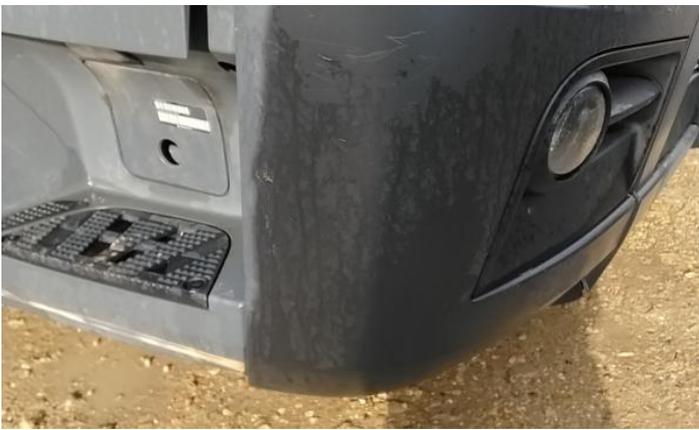
5: Bumper Front Moulding  
Scuffed (Unpainted)  
Over 100mm
